ШКОЛЕ И ЗЕМЉОТРЕС КРАЉЕВО SCHOOLS AND KRALJEVO EARTHQUAKE

3.REHABILITATION OF SCHOOLS DAMAGED BY EARTHQUAKE IN KRALJEVO ON 03. September 2010.

Over forty schools were analyzed and System DC90 technology was chosen as the solution for their seismic rehabilitation. Analyzed schools were masonry, up to four floors with reinforced concrete skeletal structures. The paper shows the ways of researching, technology design and the work carried out through implementation of our technology. Shown are the technologic and design solutions for strengthening the walls, for stiffening the ceilings, for joining ceilings with walls, for vertical prestressing of the walls and for the interconnection of the walls. The technology is especially effective on a mass repair of masonry structures when taking into account the level of safety, cost and duration of rehabilitation.

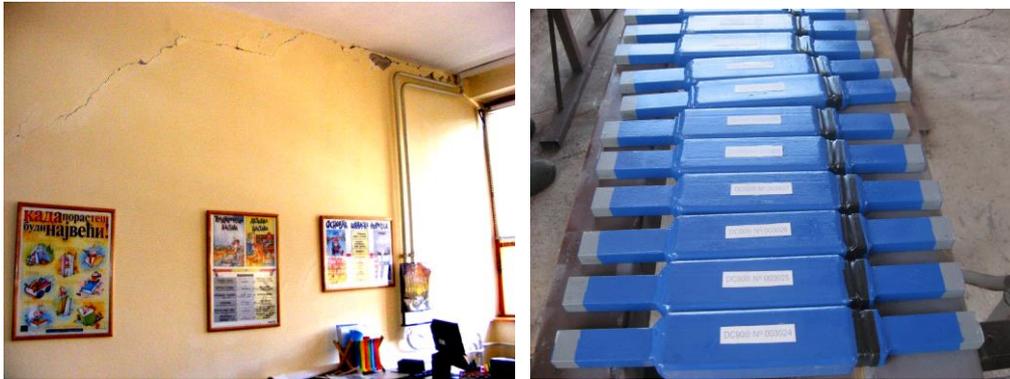
Presentation of existing damage on the structure: photo and description, with particular reference on the damage of the basic structural system. The extensive photo documentation shows that the secondary-wall systems suffered significant damage. The damage was due to the large deformability of the system, especially in the transverse direction. Poor quality of concrete walls and large distance between the concrete stiffening in the 60 m long building caused significant damage to the walls between classrooms. Deformation in the transverse direction exceeds the permissible deformation of reinforced concrete skeletal systems.

Figure.1. a wall with damages

Figure 1. Typical Damages and Dampers

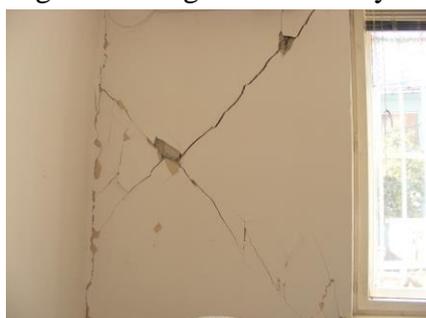
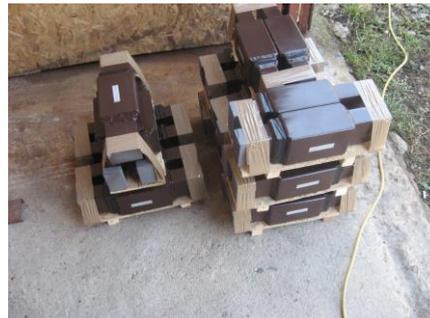
Figure 7. Typical Damages, X cracks, and Dampers

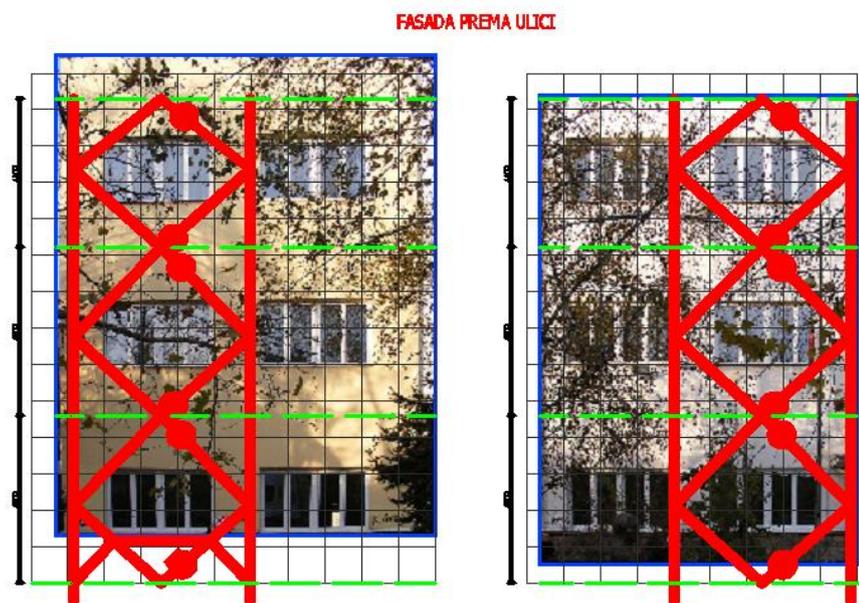
Figure 9. shows the ortho-photo shot of the facade with marked vertical stiffeners. The building was damaged badly with crossed diagonal cracks between windows.

**Figure 9.** The Shape of Stiffeners

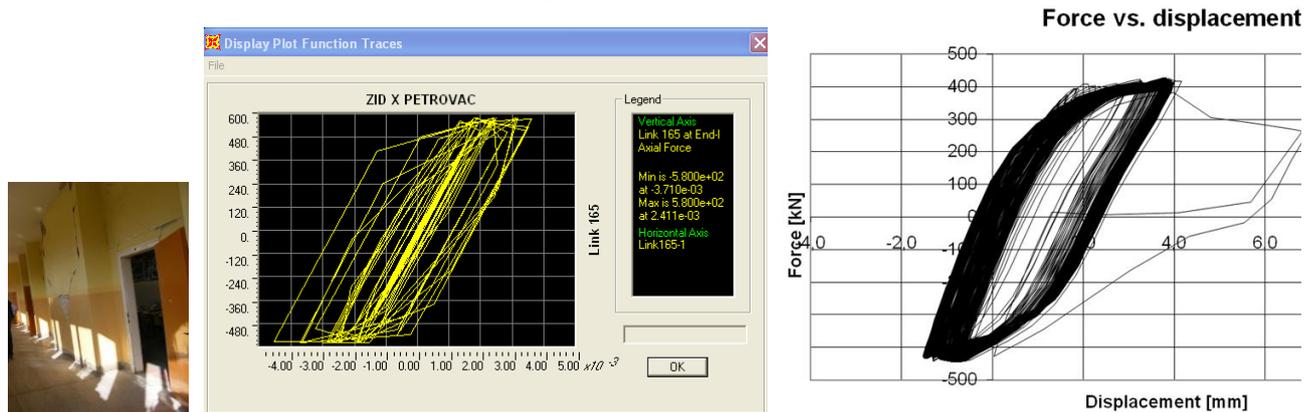
The old part of the school was made of masonry construction with reinforced concrete corners around windows, with the partition wall in the hallway made of brick on the outer side. The wall was unstable

and the ground and first floor were not allowed for use until rehabilitation. The pillars are made of brick. The inner columns were badly damaged and degraded.

Figure 10. Typical Damages and Dampers (design and test)

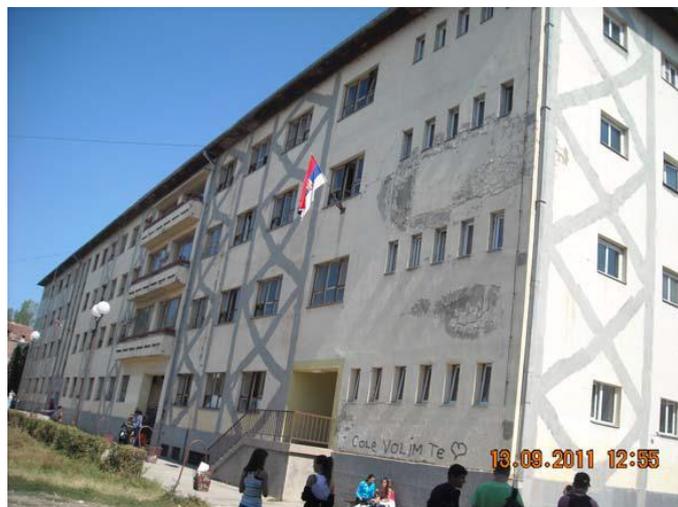
The school consists of three constructional parts separated with dilatations. Objects previously strengthened with concrete in transverse direction. There was a need for longitudinal capacity reinforcement of facade walls. During the period of observation progressive increase in cracks in the walls was apparent, particularly in the facade wall in the space between windows.

Figure 13. Beginning of retrofit

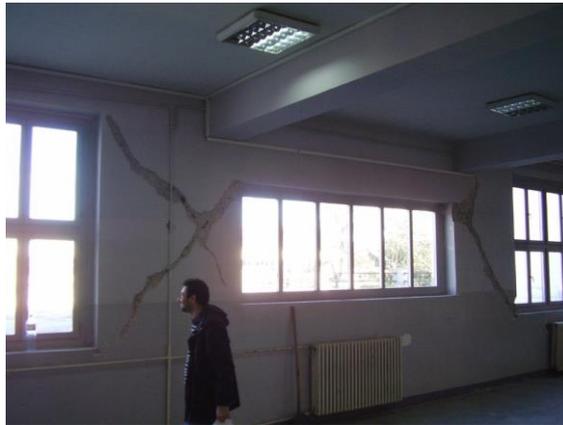
Figure 14. Typical Damages
